# Water Quality in Te Hākāpupu Pleasant River Catchment

**T**his factsheet summarises the current state of water quality in Te Hākāpupu Pleasant River catchment. It is based on monitoring data and assessments collected as part of the Toitū Te Hākāpupu project (2021–2025), a partnership between Kāti Huirapa

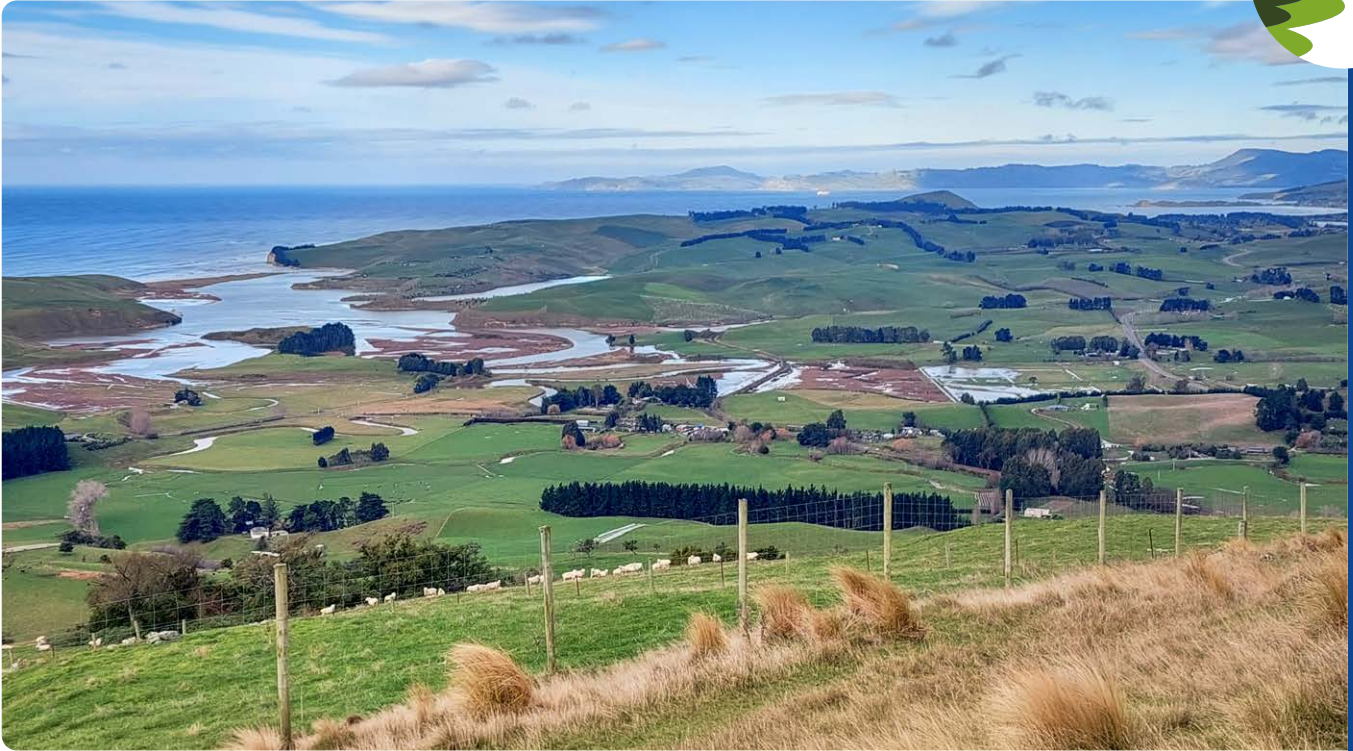
# How are contaminants getting into the water?

## Understanding how contaminants reach the river helps target management actions:

- **Sediment** is the dominant water quality issue in this catchment. It enters the waterways primarily through bank erosion and overland flow during heavy rainfall, driven by the catchment's naturally erodible hill country soils. Across the catchment as a whole, streambank and subsoil erosion are the primary sources of deposited sediment at most sites. Trotters Creek, which drains much of the upper catchment planted under exotic forest, contributes the highest proportion of total suspended sediment discharged from the catchment – reflecting both the erodibility of its sub-catchment and the elevated risk during forestry harvest.
