# Water Quality in the Waihemo Shag River Catchment

**T**his factsheet summarises the current state of water quality across the Waihemo Shag River catchment – from the upper river down to the estuary at Matakāea Shag Point, and the shallow groundwater aquifer beneath the valley floor. It is based

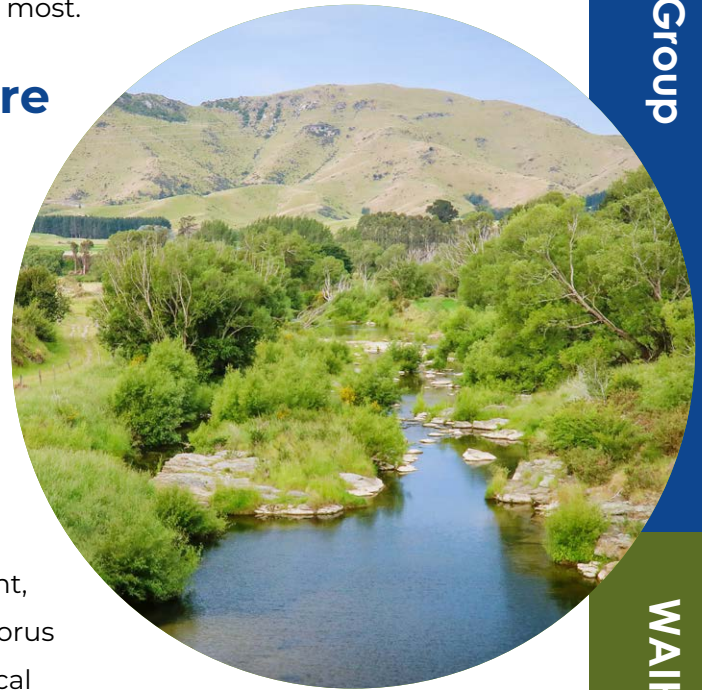
In the lower catchment a short distance downstream of Craig Road (Glenpark), the river is closely connected to the Shag Alluvium Aquifer, a shallow groundwater aquifer. This connection means that nutrients leaching through soils can enter groundwater and then flow into the river. In some river reaches, this reverses – river water is lost to groundwater.

Most sediment, phosphorus and faecal contamination enters the river during rain events through overland flow and bank erosion, while nitrogen enters mainly through leaching to groundwater.

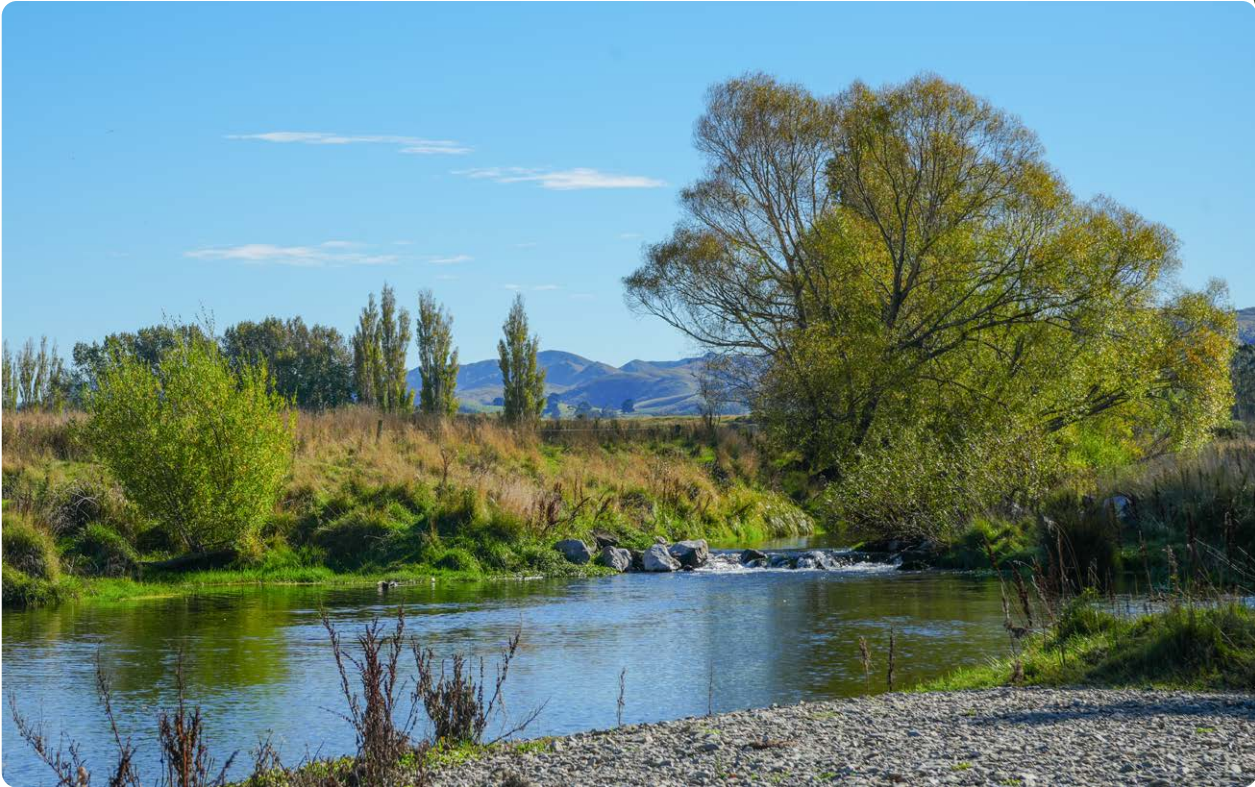
# How healthy is the Waihemo Shag River system?

- Water quality in the main river in the upper catchment (around SH85) is excellent, with very low concentrations of nutrients and sediment. Water quality is good further down the catchment at Craig Road, and drops to fair in the lower reaches at Goodwood Pump (Chisholm Road near SH1).
