# **Water quality in the Waikouaiti River catchment**

**Monitoring activities and findings**

**Prepared for: East Otago Catchment Group**

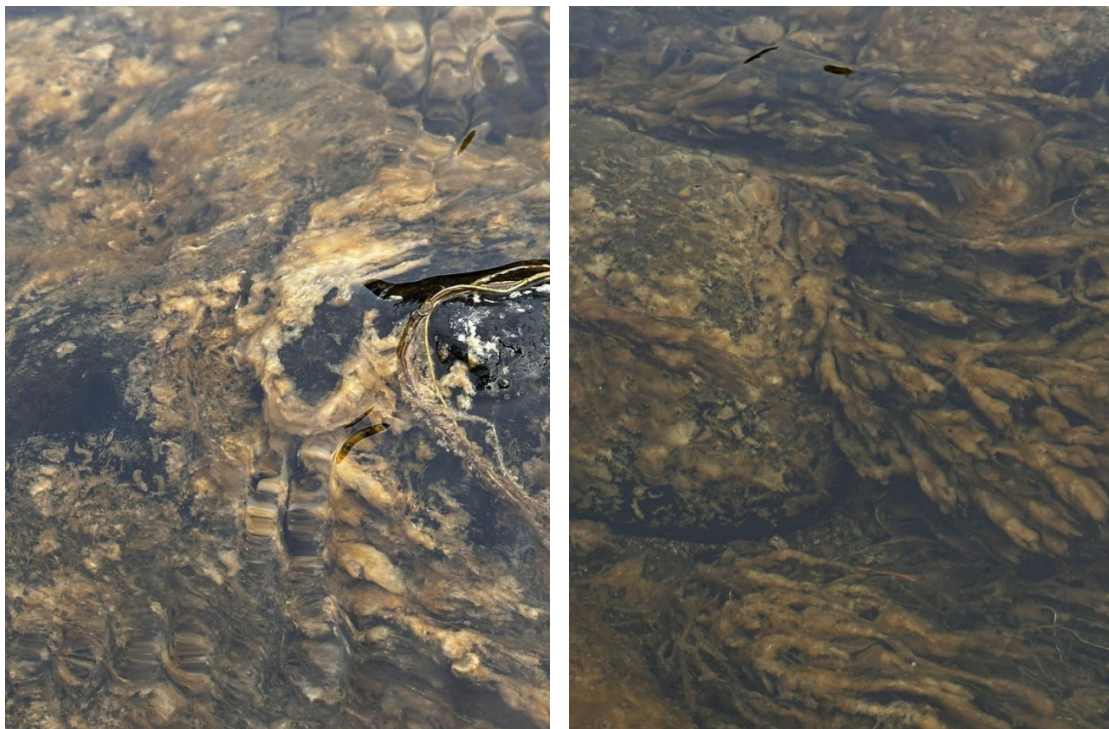
**Figure 10: Thick cover of diatom mats – likely *Gomphonosis* or *Cymbella* – observed by the author in the North Branch of Waikouaiti River downstream of Bucklands Crossing on 9 September 2025. Aquatic macrophytes (plants) were also growing along the banks and below the water's surface in places.**

Significant periphyton cover was also observed at Bucklands Crossing in September 2025 (author obs., Figure 10) and has been noted upstream at El Dorado (M. Dale, pers. comm.). Quarterly ecological assessments in the headwaters of the North Branch associated with the Macraes Mine indicate that macrophytes (aquatic plants) are more dominant than periphyton and plant cover across the channel exceeds recommended provisional national guidelines (Matheson et al. 2012) of 50%. An exception is the lower reaches of Murphys Creek where the bed is frequently covered with filamentous and mat algae (SLR 2024).

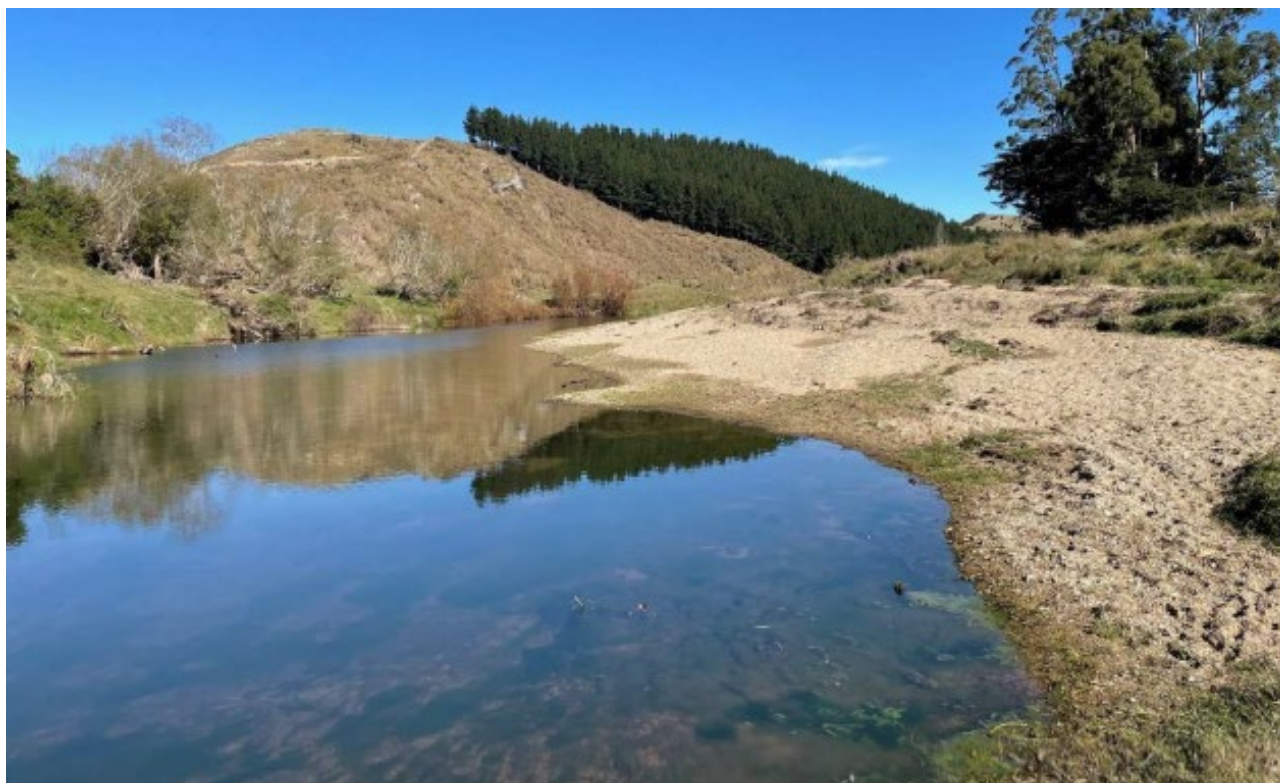
**Figure 11: Long strands of filamentous green periphyton seen in the Waikouaiti River in the vicinity of the DCC's water intake in April 2021. Photo: Beca (2022).**

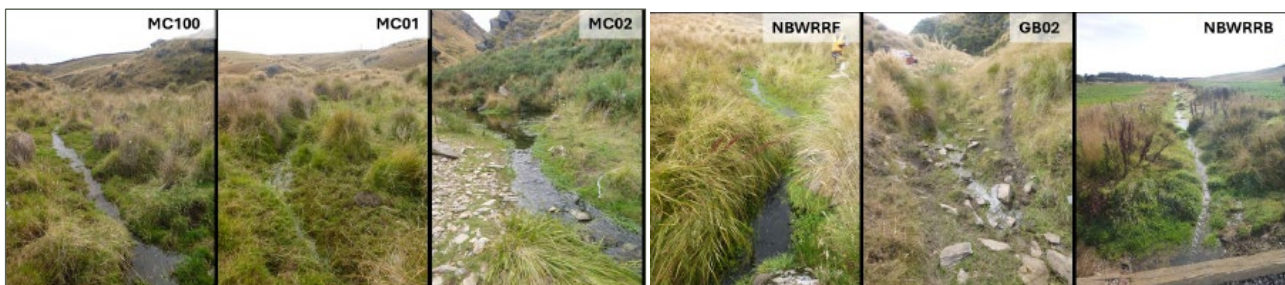
**Figure 16: OceanaGold monitoring sites in the Waikouaiti River catchment in summer 2023. Stock access is evident in several photos and faecal deposits can be seen at site MC01 (Murphys Creek). Reproduced from Figure B.5 (SLR 2024).**

Invertebrate data collected in the headwaters of the North Branch and its tributaries as part of OceanaGold's consent monitoring also indicate 'poor' to 'fair' ecological health (Figure 14). Recent monitoring reports (SLR 2024 & 2025) document an increase in macrophyte cover over time at some sites, together with declines in mayfly numbers and QMCI scores (Figure 15). Although these negative trends may be influenced by mining activities, limited surface water during dry summer periods and farming activities may also be contributing factors (SLR 2024 & 2025). Stock have access to stream margins and channels at some sites, particularly in Murphys Creek, where this has caused bank damage and pugging (Figure 16).

Suspended fine sediment concentrations are consistently low at base flows in the lower reaches of the river but are not well quantified at higher flows (i.e. during rainfall). Monitoring data is limited elsewhere in the catchment but SLR (2024 & 2025) report disturbance of the bed and pugging by stock in some of the headwater tributaries. There is likely also localised bank erosion contributing to fine sediment into streams at base flows. For example, although City Forests' annual SHMAK assessments in the South Branch indicate that bed sediment cover is generally consistently low, the summary scores provided for this report suggest that fine sediment is sometimes present near the banks.

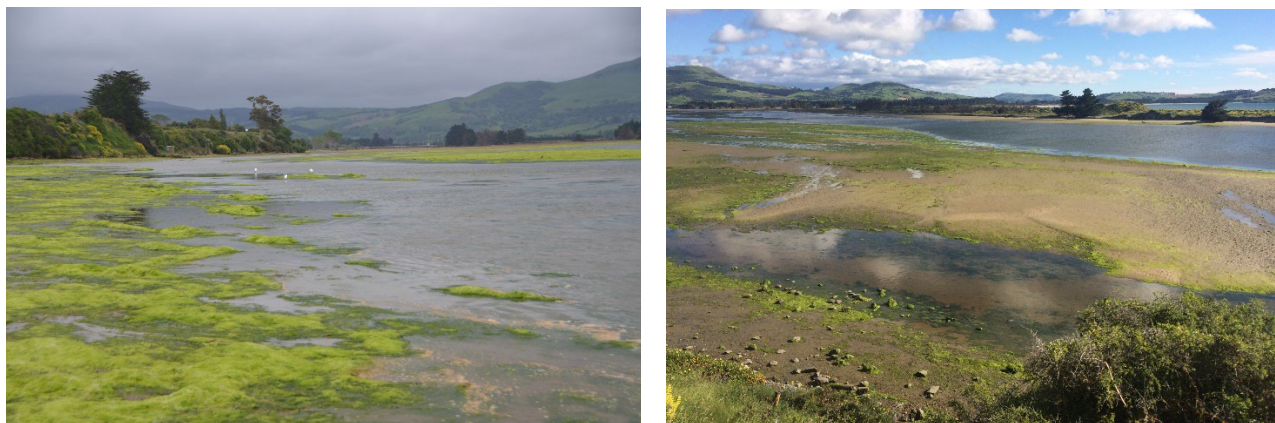
**Figure 23: Green macroalgae blooms in the middle (left) and lower (right) reaches of the Waikouaiti Estuary near the main channel in December 2016.** Photo from Stevens and Robertson (2017).

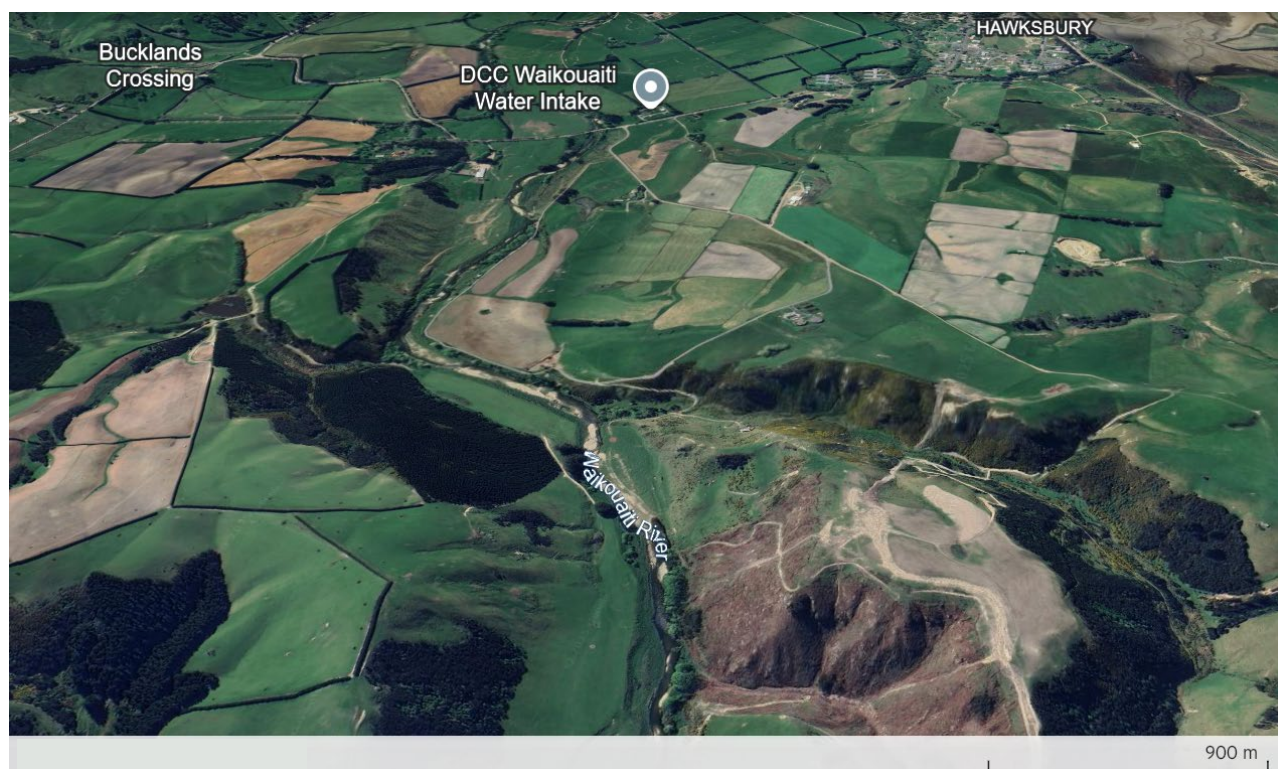
**Figure 24: Aerial photo (November 2023) looking down over the lower South Branch of the Waikouaiti River, with harvested forest in the foreground.** Google Earth, accessed October 2025.

Plantation forestry cover has increased in some areas of the catchment in the last decade, in part to reduce hillslope erosion. However, some of the long-established forest, particularly in the South Branch, is progressively undergoing harvest (Figure 24) and this will need careful management to prevent sediment loss to surface water. With significant reaches of both branches bordered by steep-sided slopes that are in places considered at high risk of erosion (Figure 25), managing sediment loss, particularly in heavy rain events, may be a challenge.
